# FACILITY COMPLIANCE AUDIT REPORT

## Division of Waste Management Solid Waste Section

Avery Co. MSW Landfill - Closed

Comprehensive Audit

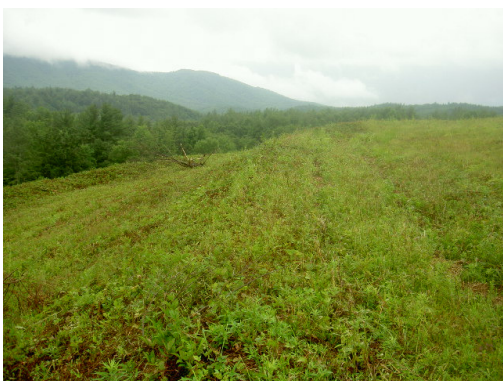
1. Looking (E) at (N) portion of the top of the closed MSWLF.

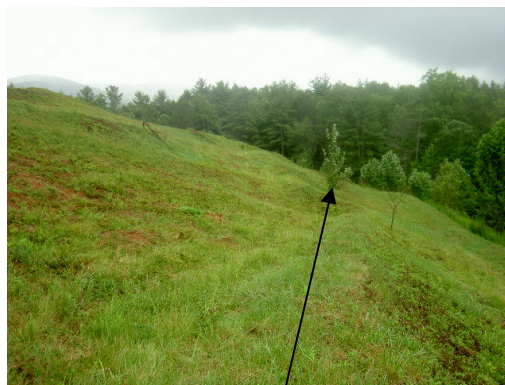
2. Looking (E) at (S) slope of the closed MSWLF. Several trees need to be removed.

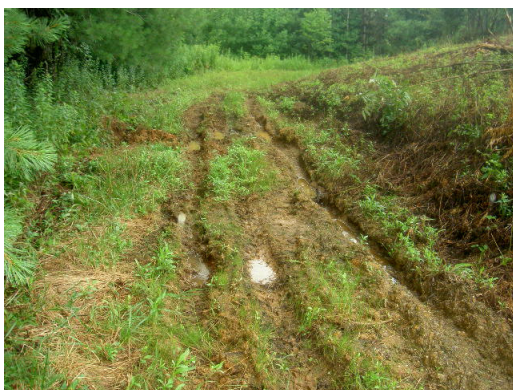
1. The access road at the base of the western edge of the landfill needs maintenance – it is very wet and rutted to the point where it is almost impassable. (See photo #3 below.) Per 15A NCAC 13B .0505(8) “Access and Security Requirements” part (c), *the access road to the site shall be of all-weather construction and maintained in good condition.*
2. A cable was strung across the access road entrance to prohibit unauthorized entry.
3. All three groundwater monitoring wells appear to be in good repair and are properly locked and marked

3. Access road at the base of the LF, on the (W) side: Needs repair before it becomes impassable.

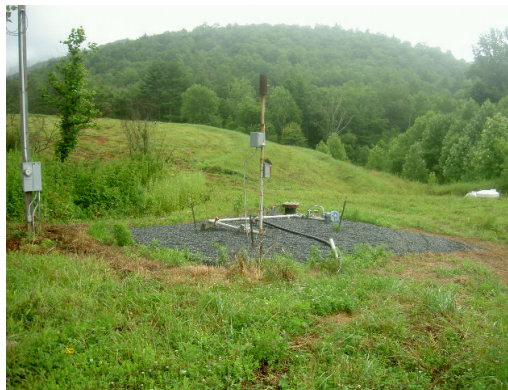
4. New gravel at the base of the landfill gas flare to provide an inflammable surface.

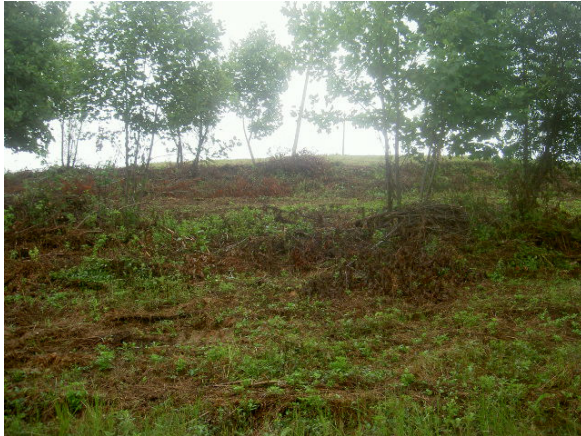
5. Look up the slope on the (W) side of the landfill – these trees must be removed.

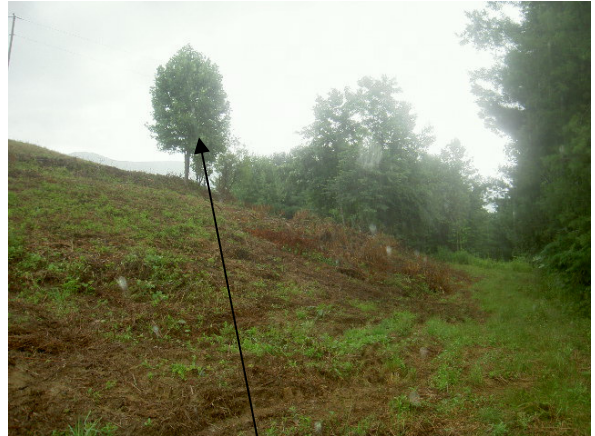
6. Looking (S) at trees on the (W) slope of the landfill that must be removed.
